**DEPARTMENT OF TRANSPORTATION**

Quality Assurance and Source Inspection

Contract #: 04-0120F4Cty: SF/ALA Rte: 80 PM: 13.2/13.9File #: 1.28**WELDING INSPECTION REPORT****Resident Engineer:**Siegenthaler, Peter**Address:** 333 Burma Road**City:** Oakland, CA 94607**Report No:** WIR-023481**Date Inspected:** 07-May-2011**Project Name:** SAS Superstructure**OSM Arrival Time:** 700**Prime Contractor:** American Bridge/Fluor Enterprises, a JV**OSM Departure Time:** 1530**Contractor:** American Bridge/Fluor Enterprises, a JV**Location:** Job Site**CWI Name:** Pat Swain**CWI Present:** Yes No**Inspected CWI report:** Yes No N/A**Rod Oven in Use:** Yes No N/A**Electrode to specification:** Yes No N/A**Weld Procedures Followed:** Yes No N/A**Qualified Welders:** Yes No N/A**Verified Joint Fit-up:** Yes No N/A**Approved Drawings:** Yes No N/A**Approved WPS:** Yes No N/A**Delayed / Cancelled:** Yes No N/A**Bridge No:** 34-0006**Component:** Tower**Summary of Items Observed:**

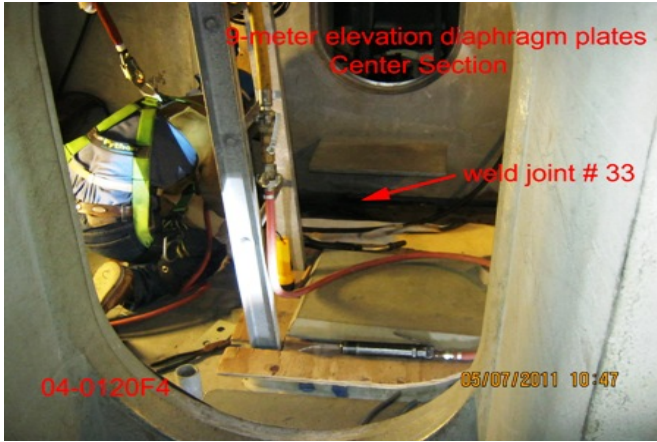
This QA Inspector had observed ABF welding personnel working at weld joints #33 and #35 the previous day and was informed today that welding would continue at these locations. Weld joints #33 and #35 inside the center section to shear plates b2W and b2E. See photo below.

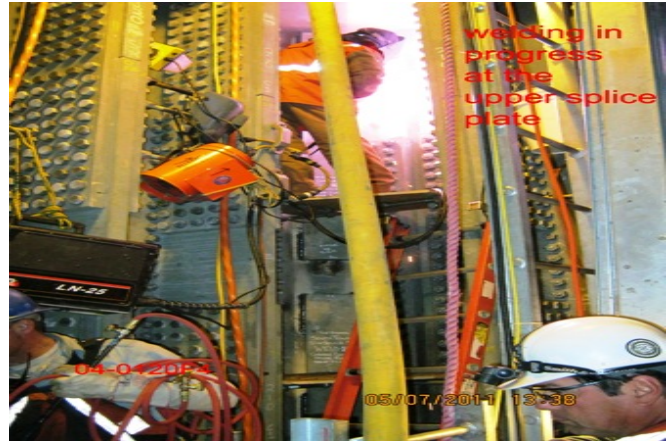
This QA Inspector randomly observed ABF welding personnel Salvador Sandoval (#2202) tack welding the upper and lower splice plates located at the B-C skin corner. This QA Inspector observed QC Inspector Steve Jensen verify the following FCAW parameters; 256 amperes and 22.1 volts at a travel speed of 100 mm per minute to produce a heat input of 3.39 Kj per mm. The welding observed appeared to comply with ABF-WPS-D15-F2200-3. See photo below.
